DEPARTMENT OF TRANSPORTATION

Quality Assurance and Source Inspection

Contract #: 04-0120F4Cty: SF/ALA Rte: 80 PM: 13.2/13.9File #: 69.28**WELDING INSPECTION REPORT****Resident Engineer:** Pursell, Gary**Address:** 333 Burma Road**City:** Oakland, CA 94607**Report No:** WIR-000171**Date Inspected:** 17-May-2007**Project Name:** SAS Superstructure**OSM Arrival Time:** 800**Prime Contractor:** American Bridge/Fluor Enterprises, a JV**OSM Departure Time:** 1400**Contractor:** Zhenhua Port Machinery Company, Ltd (ZPMC), Changxing Island **Location:** Shanghai, China**CWI Name:** Huang Wei**CWI Present:** Yes No**Inspected CWI report:** Yes No N/A**Rod Oven in Use:** Yes No N/A**Electrode to specification:** Yes No N/A**Weld Procedures Followed:** Yes No N/A**Qualified Welders:** Yes No N/A**Verified Joint Fit-up:** Yes No N/A**Approved Drawings:** Yes No N/A**Approved WPS:** Yes No N/A**Delayed / Cancelled:** Yes No N/A**Bridge No:** 34-0006**Component:** N/A**Summary of Items Observed:**

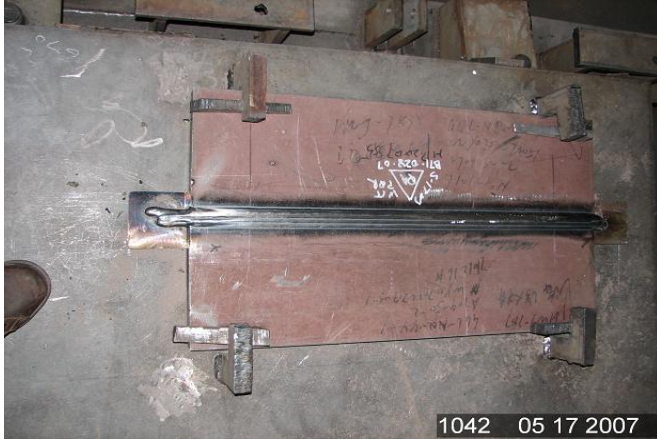
The QA inspector performed final visual examination to the test coupon after completion of the PQR HP200785.

The QA inspector observed that the welds appeared to be in general compliance with the contract documents. The QA inspector assigned a lot # B71-028-07 on this date. The digital photograph below shows the PQR test coupon.

Note: The PQR was welded at fabrication shop on the SAW Gantry machine.
